THE LAKELANDS, LOWER GALE, AMBLESIDE

BACKGROUND TO LEISURE COMPLEX REPAIRS/ REFURBISHMENT

AMW/TBM/AWA775

April 2021

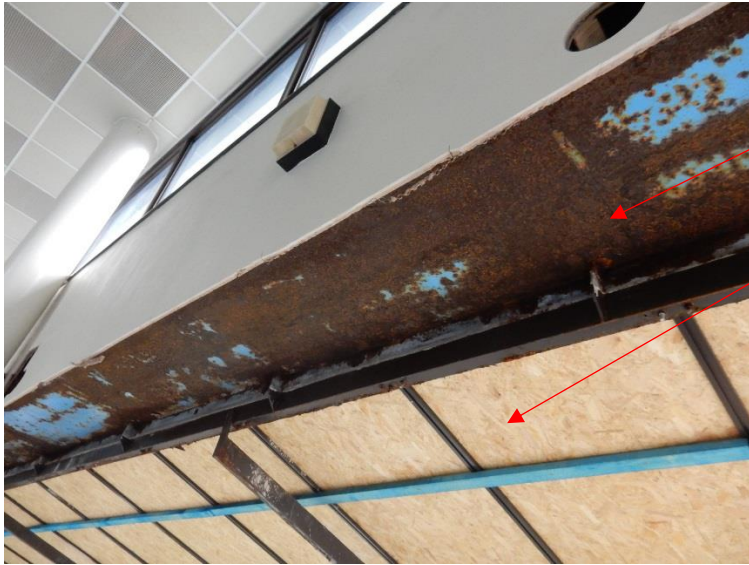
The beam in the leisure centre is of continuous solid steel over 16 metres long, supported in two spans onto three internal steel columns. It supports the wall and glazing at first floor level and the glazed roof at ground floor level. To assess the damage caused, it was exposed where the water ingress was most severe at the north end of the pool, and examined in more detail in the plant room. The beam is very badly corroded at these points to the extent that its structural integrity is seriously compromised.

We therefore removed areas of internal plasterboard and external masonry, which revealed that the entire beam is corroded to varying degrees, which is severe in many areas, particularly on the external face where it is in almost constant contact with wet masonry. The base of the supporting columns are also badly corroded due to the effects of chlorinated water, resulting in loss of strength.

Underside of beam before propping, showing extensive and severe corrosion over most of its length due to water ingress and condensation. Glazing to roof removed in preparation for installation of props

A structural propping system was therefore designed and installed in December 2019 pending complete replacement, and the pool was closed due to health and safety issues. The beam above the north entrance, supporting the wall and window above, has also been found to be badly corroded and requires substantial repair. These repairs have now been specified by the structural engineer.

Given that the windows will also require replacing whatever happens to the beam, it is more efficient to design the beam out altogether and replace it with a continuous two storey glazed elevation. The proposed scheme greatly enhances the experience for users of the complex, optimising the spectacular views from the pool. This requires careful detailing to ensure this integrates with the building fabric and to ensure a weathertight and structurally sound solution.

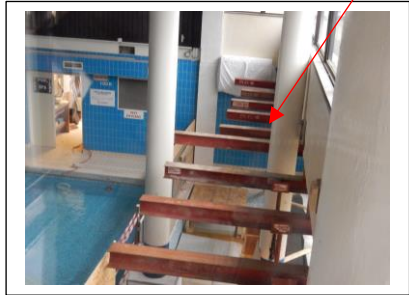
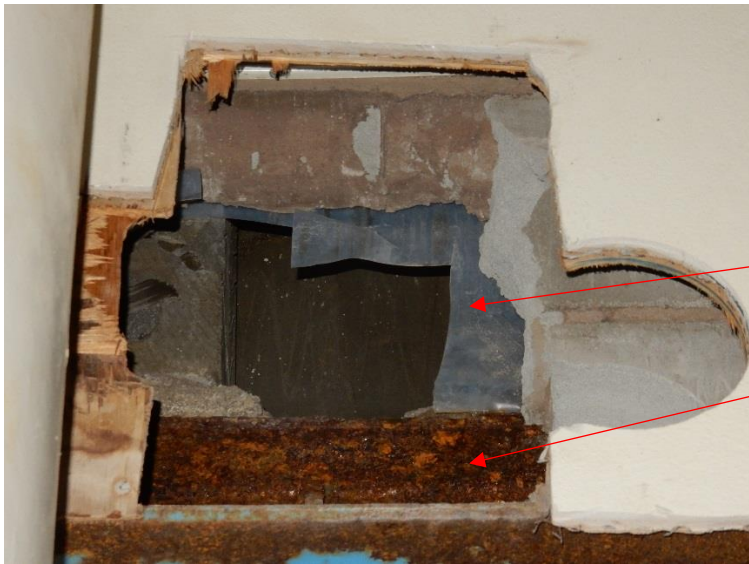
In addition, there were multiple points of water ingress through the poorly built wall above the beam, along with condensation forming on the beam due to the inadequate insulation and very high levels of humidity caused by inadequate ventilation. These add to the corrosion and drip onto the floor below.

Plasterboard lining removed to exposed beam and wall construction.
Damp proofing very poorly detailed and no insulation resulting in condensation and water ingress.
Beam very badly corroded

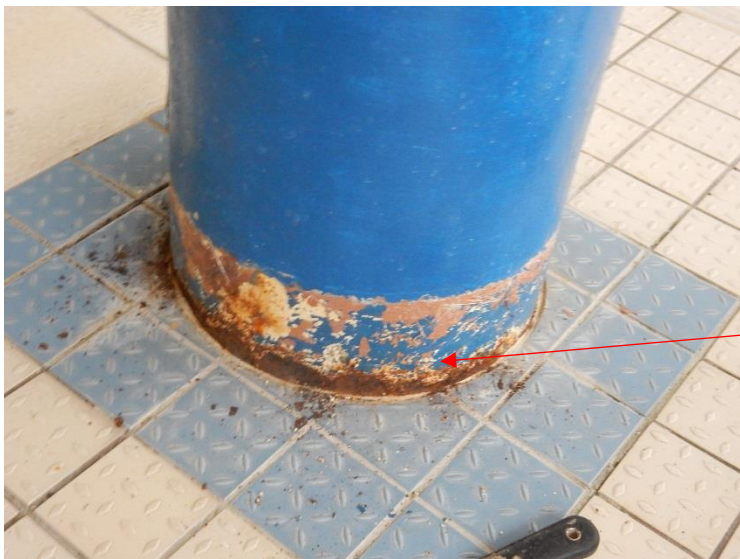
Corrosion to foot of columns requiring repair

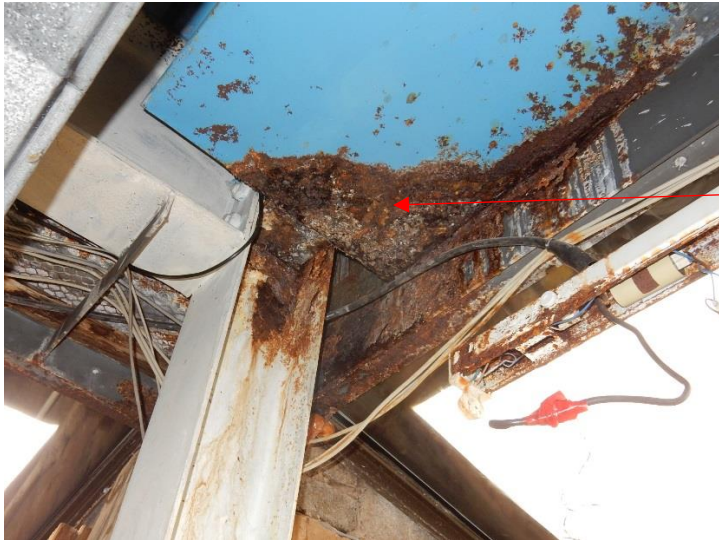
The planters at the south end above the plant room were not rebuilt. These were a poor design from the outset, built with inappropriate materials and had no means of drainage or air flow. While the soil was removed, they were poorly capped so that rainwater continued to run into the trough, where it simply accumulated and saturated the blockwork, damaging the render and causing varying degrees of damp. In particular, at the south west corner this ran off the edge of the concrete balcony deck into the plant room onto the bearing of the beam and column and electrical equipment.

Corrosion to steel beam above plant room caused by water ingress from voids in parapet wall above

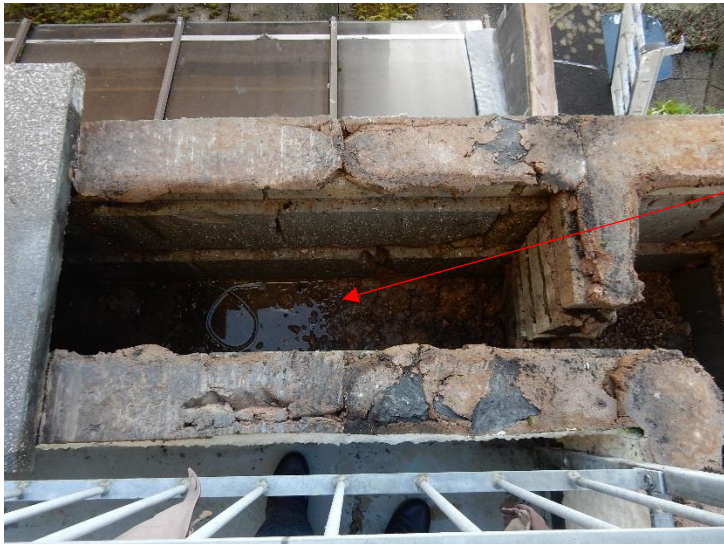
The parapet walls were originally designed as troughs for planting, but had long been felt to be a source of leaks and damp, so the west facing parapets outside Apartments A-D were rebuilt in 2004 in steel reinforced solid blockwork with steel railings. However, our investigation found water ingress between the new parapet and the wall above the glazed roof. This has now been remedied, but by then it had severely damaged key structural steelwork.

Standing water in parapet walls – formerly planters

Balconies and parapets: this was initially proposed for a second phase to try to manage costs, but recent collapse of render at high level has brought this to the fore as a health and safety issue. The render in this area has been replaced and made safe but due to the poor construction of the parapets as a whole rebuilding these has to be brought forward. This has implications for the balcony surfaces (the new parapets will be narrower), thus bringing forward the balcony resurfacing work.

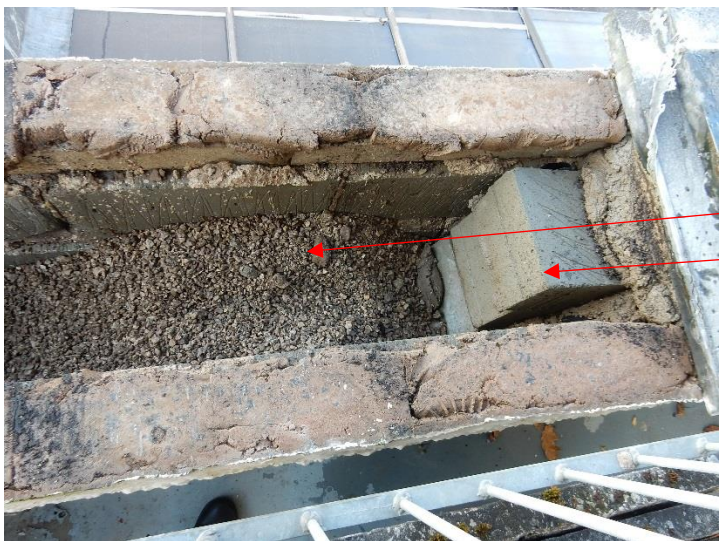
Parapet above bearing of beam in plant room – part filled with gravel, end of trough roughly infilled with blockwork, resulting in water running off end of deck at bottom of trough into plant room.
